**U.S. ENVIRONMENTAL PROTECTION AGENCY  
REGION 5**

**CWA OVERSIGHT INSPECTION REPORT  
ILLINOIS**

<b>Inspection facility</b>	Hollis Shafer Swine Farm 785 North Taylor Lane Astoria, Illinois 61501
<b>NPDES permit status</b>	No permit
<b>IEPA inspection date</b>	04/16/12
<b>EPA inspection date</b>	09/14/12

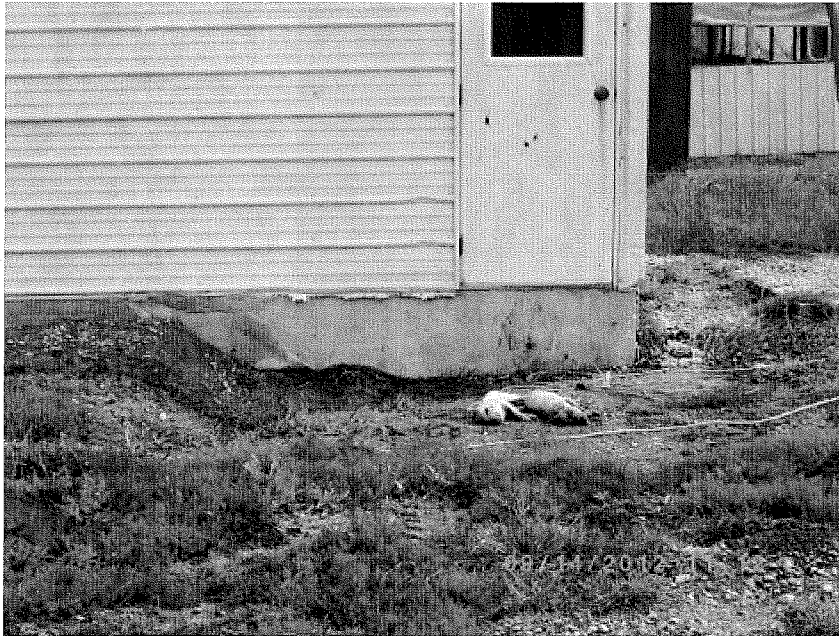
IMGP1570: Mortalities by Nursery.  
Location: In the yard west of the Nursery Building  
Facing: East  
Date/Time: 09/14/12 11:12 A.M.

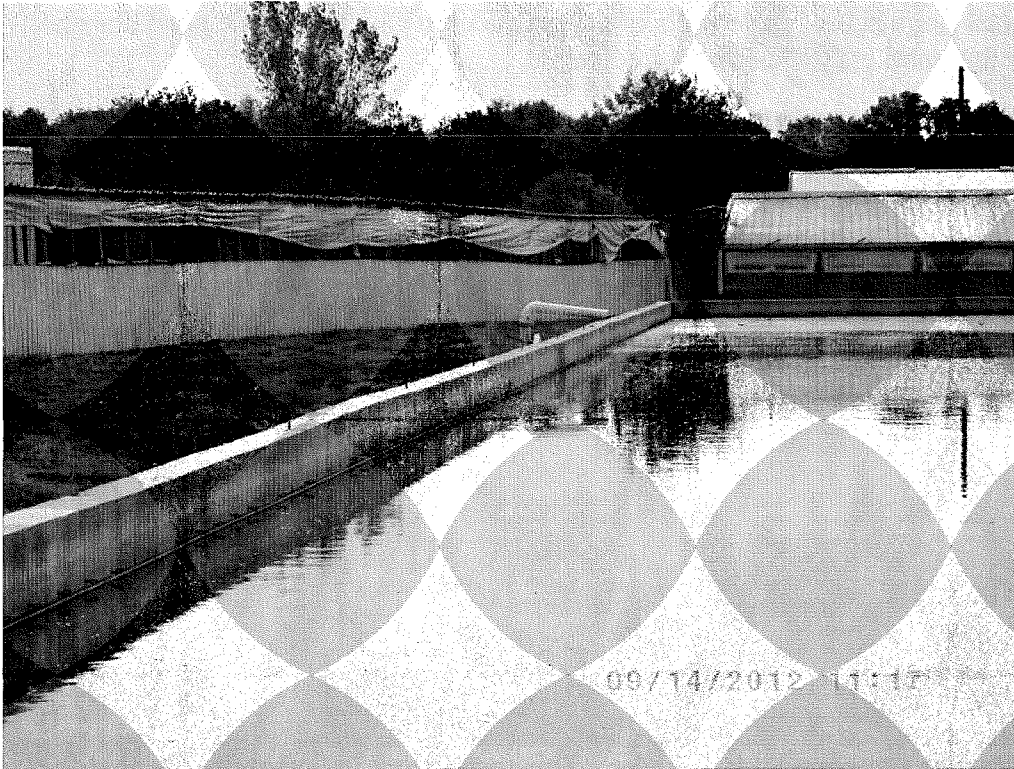
IMGP1574: Inlet pipe from South Pump Station to Concrete Pit. Concrete Pit is almost into the 2' of freeboard capacity.  
Location: North of Concrete Pit  
Facing: South  
Date/Time: 09/14/12 11:17 A.M.

- b. Liquid manure should be removed to attain at all times a minimum of 2 feet of freeboard.
  - c. The integrity of the berms should be properly evaluated, with any found problems with the berms properly addressed.

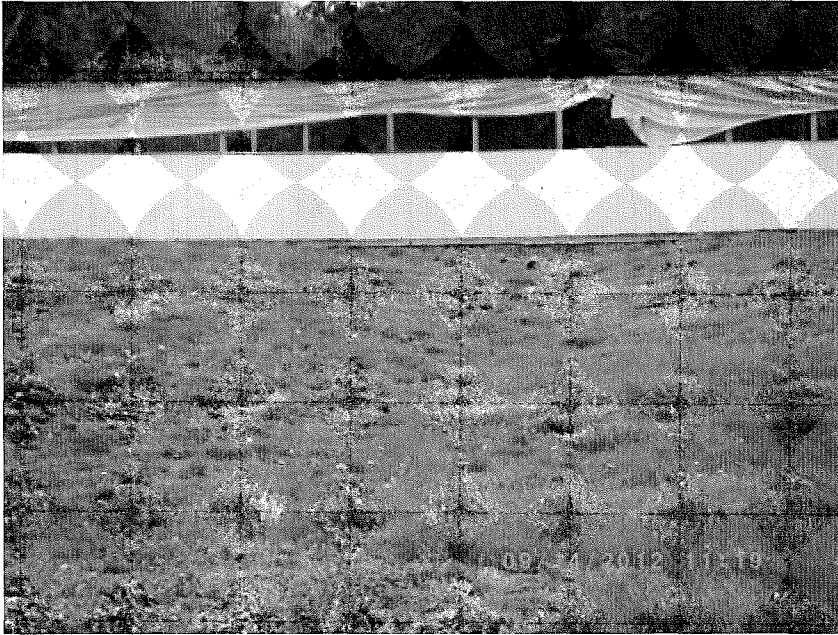
The swine walkway continued to the south past the Nursery Building, the Concrete Pit and attached to Gestation Building G. Another culvert pipe under the swine walkway south of the Concrete Pit but north of Gestation Building G conveyed storm water from the west side of the walkway to the east.

IMGP1575: Culvert pipe for storm water under walkway north of Gestation Building G.  
Location: South of Concrete Pit  
Facing: East  
Date/Time: 09/14/12 11:19 A.M.

On the east side of the swine walkway north of Gestation Building G, EPA observed the storm water culvert pipe that directed storm water from the west to the east. Any manure that would leak from the crack in the walls of the Concrete Pit could flow with storm water through this culvert pipe to the hillside to the east and then to the intermittent unnamed tributary of Sugar Creek.

3. Manure leaking from the Concrete Pit could flow with storm water to the east and through the culvert pipe under the swine walkway and to the intermittent unnamed tributary of Sugar Creek.

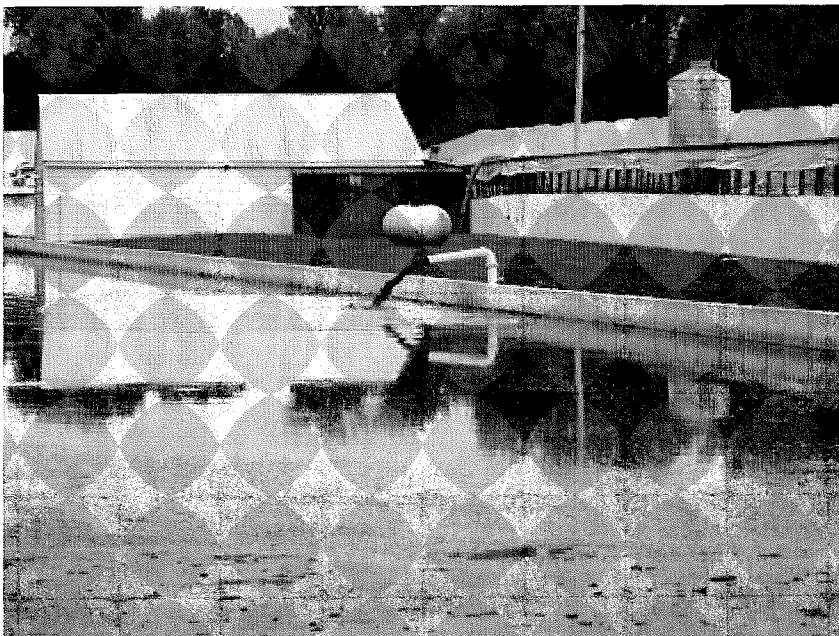
Location: South of Concrete Pit

EPA also observed the pipe which transported manure from the South Pump Station to the Concrete Pit. The manure was flowing at the time of the inspection.

IMGP1577: Manure flowing into Concrete Pit from South Pump Station.

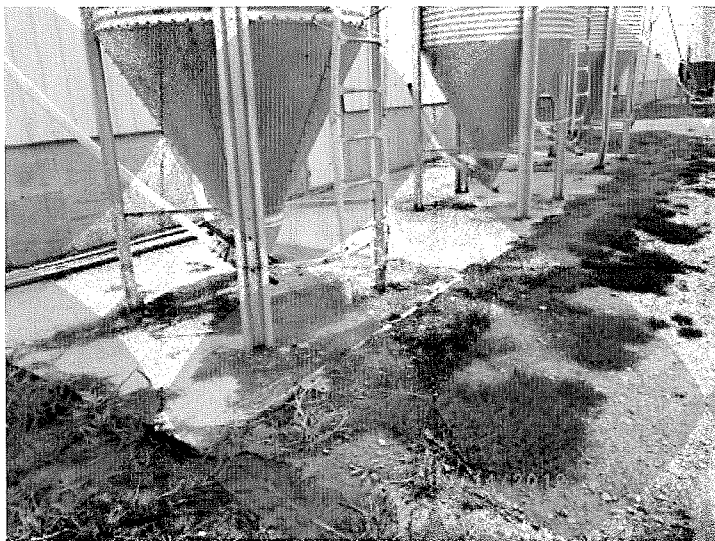
EPA noted a small amount of spilled feed beneath the bulk bins on the west side of Gestation Building J. Another pathway for leaking cooling cell water was also observed to flow toward the west from the southwest corner of the South Farrowing Building toward the crop field.

IMGP1585: Small amount of feed spilled on the ground under feed bulk bins on the west side of Gestation Building J.  
 Location: West of Gestation Building J  
 Facing: Southeast  
 Date/Time: 09/14/12 11:29 A.M.

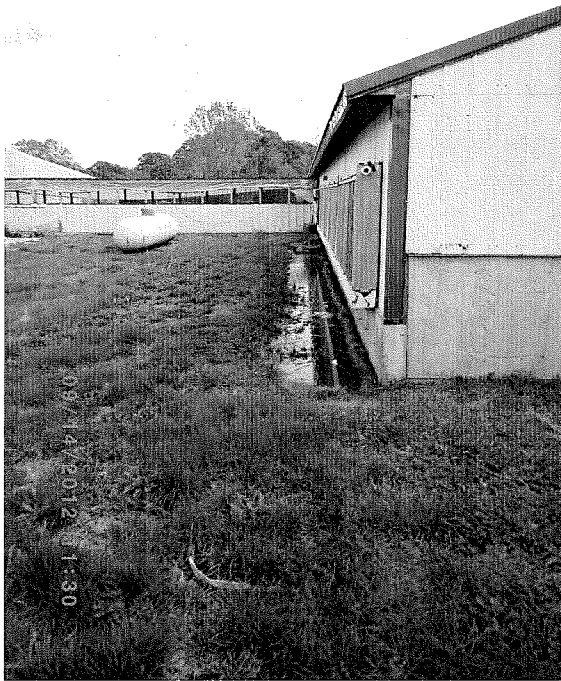
Gestation Buildings J and K and the South Farrowing Building had cooling cells attached to the windows of the building. The cooling cells forced the outside air to flow through water and the process of evaporation cooled the air before it entered the barn. A leak in the water line allows clean water to pool on the ground beneath the cells. The water has channelized and flows to the west toward a crop field.

IMGP1586: Water on ground from cooling cells for Gestation Building K.  
 Location: Northwest corner of Gestation Building K  
 Facing: East  
 Date/Time: 09/14/12 11:30 A.M.

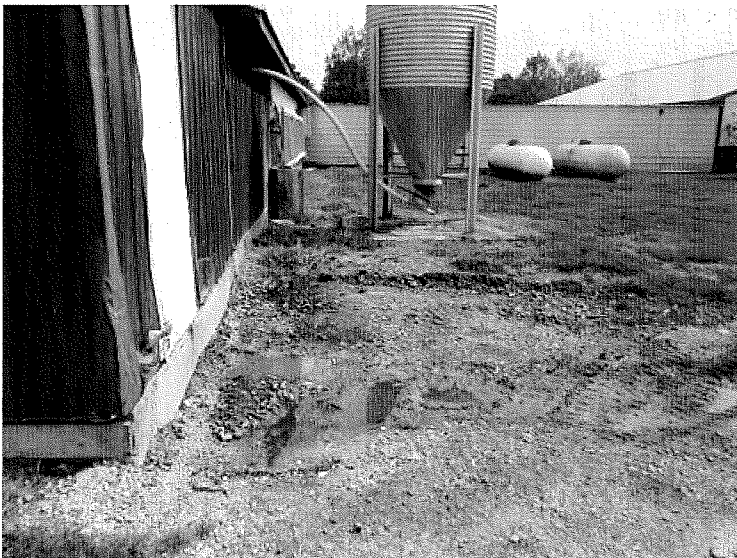
IMGP1587: Bulk bin and puddle of water on south side of South Farrowing Building.  
 Location: Southwest corner of South Farrowing Building  
 Facing: East  
 Date/Time: 09/14/12 11:34 A.M.

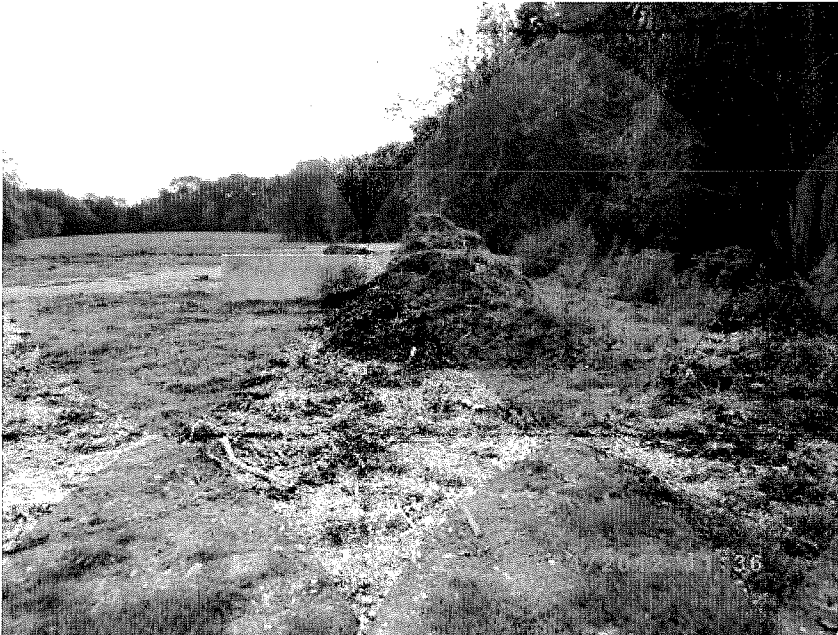
IMGP1589: Raw material for composting is in the pile next to South Compost Unit.  
 Raw material is chopped trees and mulch.  
 Location: South Compost Unit  
 Facing: South  
 Date/Time: 09/14/12 11:36 A.M.

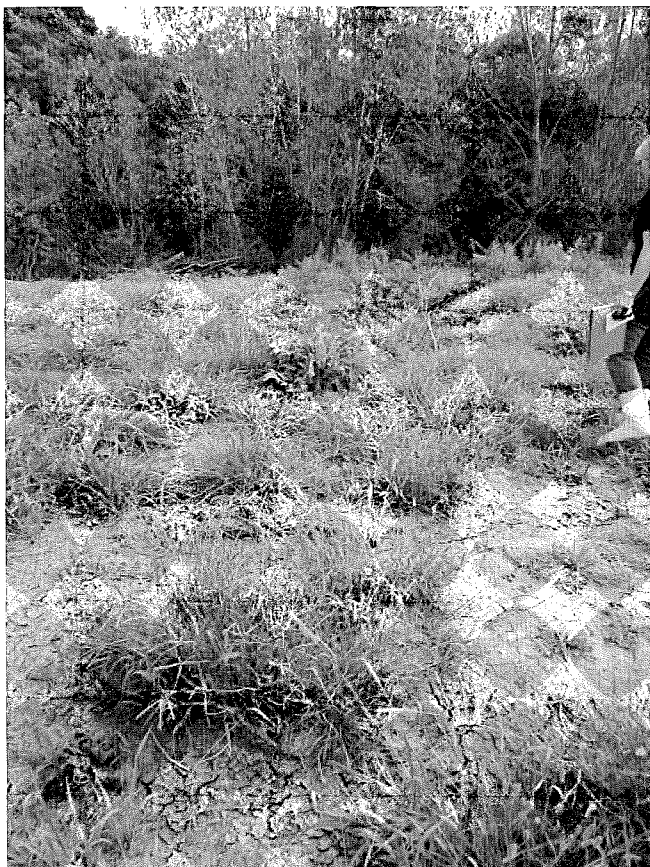
Location: East of Emergency Pond

A storm water gully in the hillside to the east allowed storm water to flow to the intermittent unnamed tributary of Sugar Creek to the east.

IMGPI594: Storm water gully to the hillside to the east.

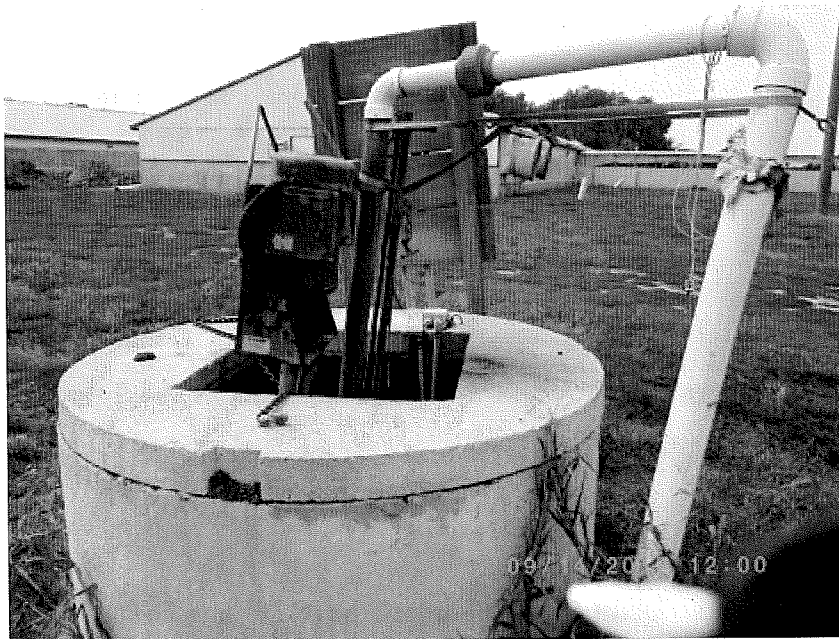
EPA also inspected the South Pump Station which was located just to the east of Gestation Building J.

IMGP1598: South Pump Station is east of Gestation Building J.  
Location: East of Gestation Building J  
Facing: West  
Date/Time: 09/14/12 12:00 P.M.

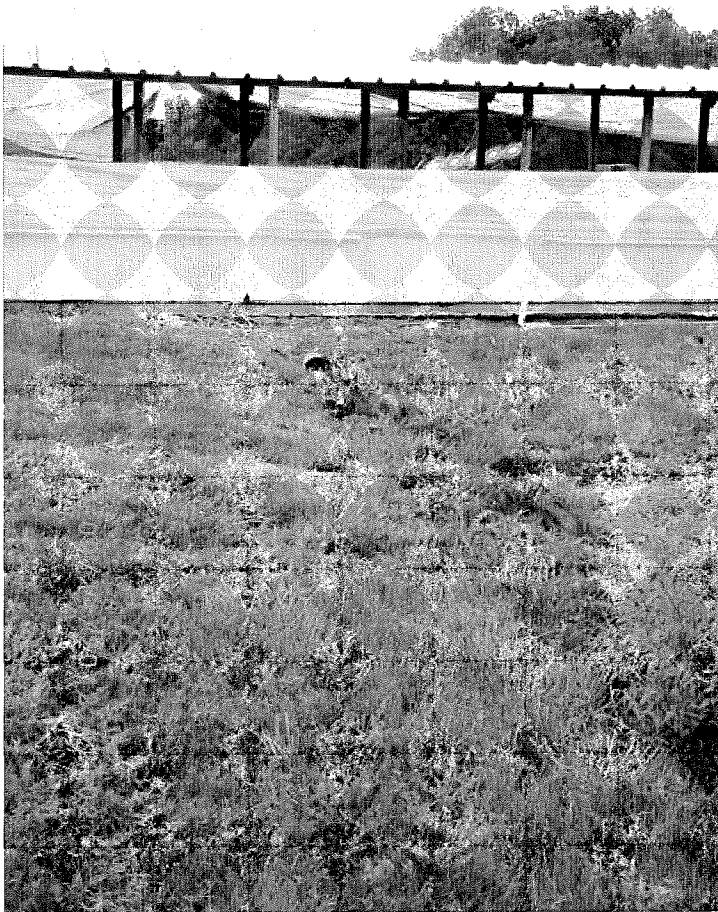
Location: Northeast of Gestation Building G

IMGP1599: Storm water culvert pipe under walkway east of the Concrete Pit. Storm water flows to the east

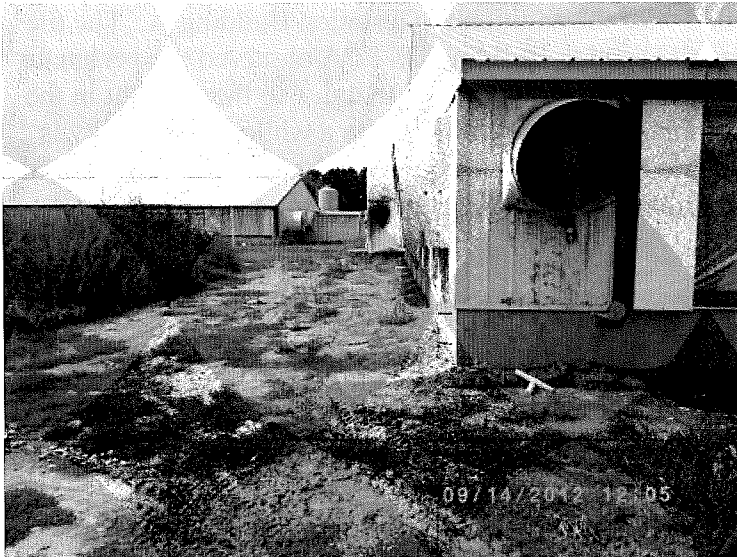
Continuing along the east side of the facility, EPA observed the addition to Gestation Building A. This new addition, built in 2011, to the building has a 10' pit beneath it which is pumped out and taken directly to the fields for land application.

IMGP1600: Gestation Building A has been extended to the south. Gestation Building F is in background.

Location: Southeast corner of Gestation Building A

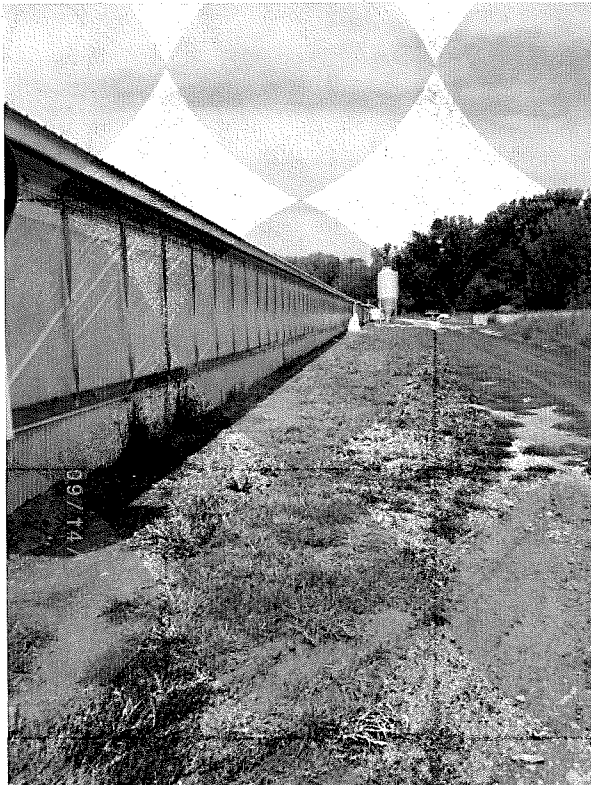
IMGP1601: Looking north along east wall of Gestation Building A.

Location: Southeast corner of Gestation Building A

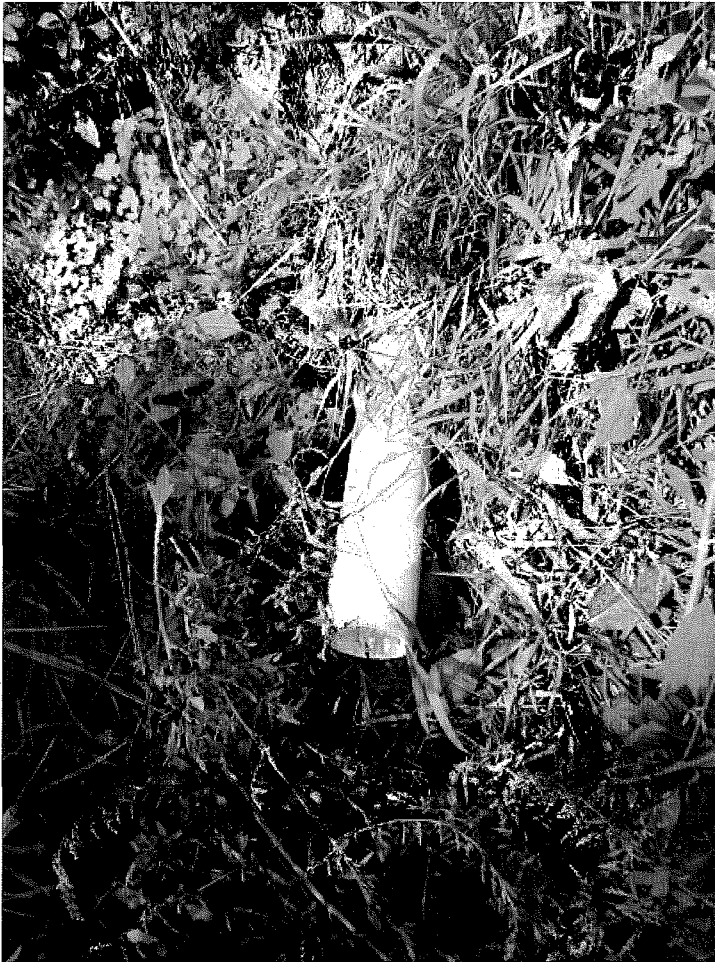
A perimeter tile drain was installed with the addition to Gestation Building A. The tile drained to the hillside to the east of Gestation Building G. EPA observed the perimeter tile drain outlet. It was not flowing and Mr. Wittig stated that due to the drought in the region, there has not been any flow from the drain tile in quite a while. The facility is required to sample the discharge (when flowing) on a quarterly basis and send the results to the Illinois Department of Agriculture. Mr. Wittig stated that the facility has been taking the required samples.

IMGP1602: Perimeter tile drain outlet in hillside east of Gestation Building G. Facility samples the discharge from the perimeter tile on a quarterly basis and the results are sent to the Illinois Department of Agriculture. Due to the drought in the region, there has not been any flow from the drain tile.

Location: East of Gestation Building G

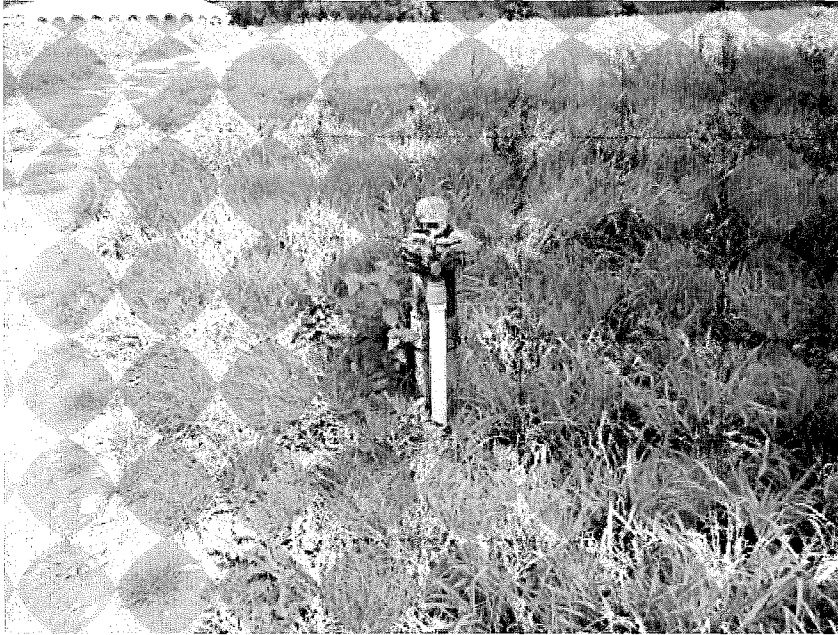
Mr. Wittig pointed out a wellhead for a 1200' well which was unusable because the well dried up due to the drought. A new, deeper well had to be dug to provide water for the animals.

IMGP1603: Wellhead for a 1200' well which is unusable because it has dried up due to the drought.

Location: East of Gestation Building G

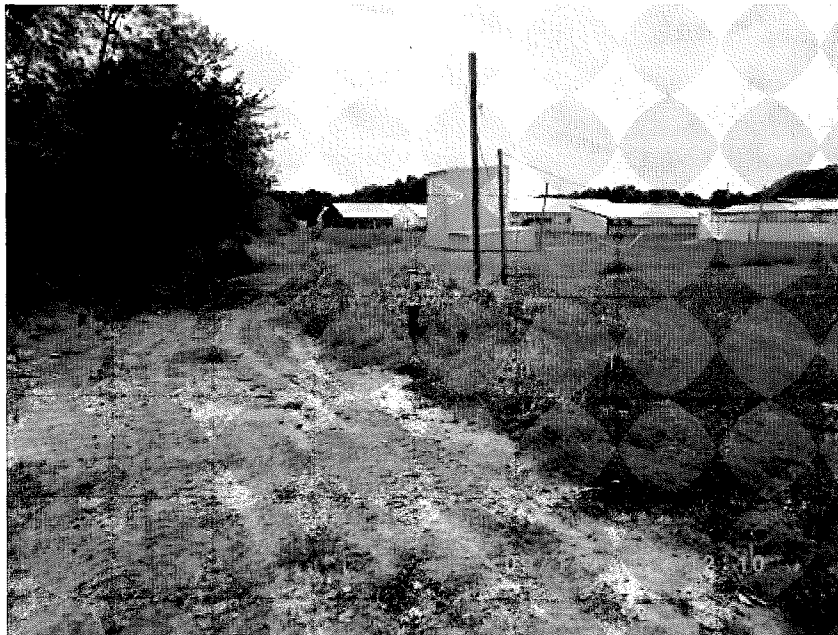
IMGP1604: Wellheads for wells for water for the facility.

Location: East of Gestation Building G

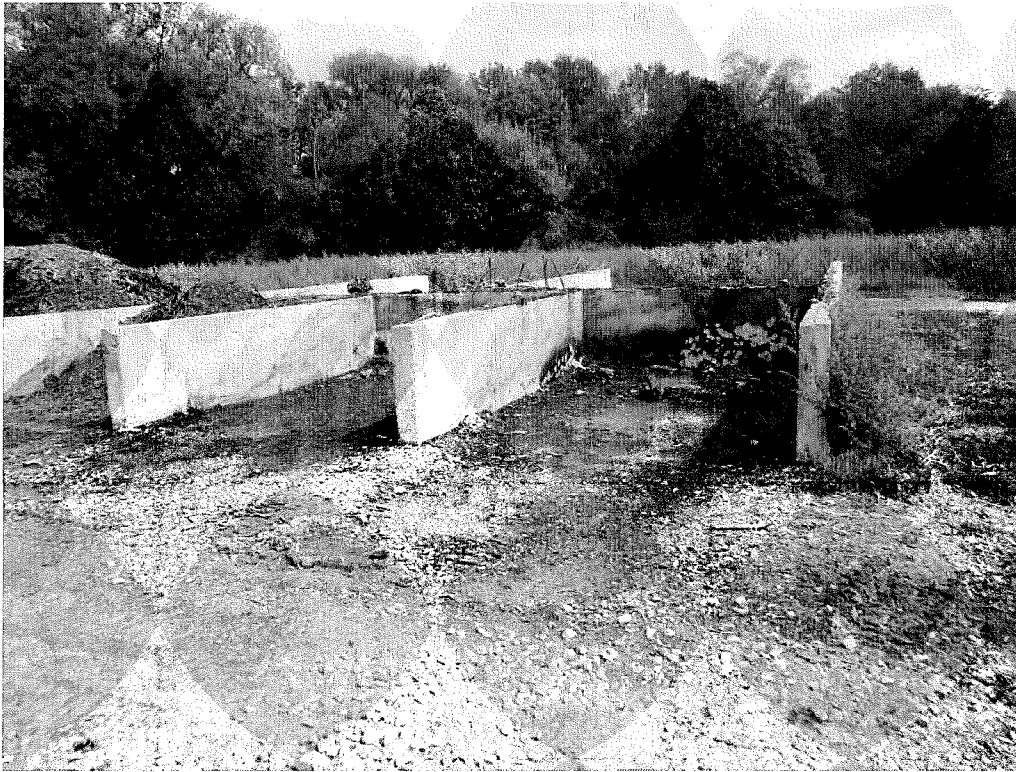
East of Gestation Building A is the North Compost Unit. This composting unit contains three bins that are open to the west and two bins that are open to the east. The mortalities were better covered in these bins compared to the condition of the South Compost Unit, but the east side bins contained mortality leachate where an abundance of flies were breeding. EPA also observed bones around the composting unit.

IMGP1605: West side bins of the North Compost Unit. Composting carcasses were covered better than in the South Compost Unit.

Location: North Compost Unit

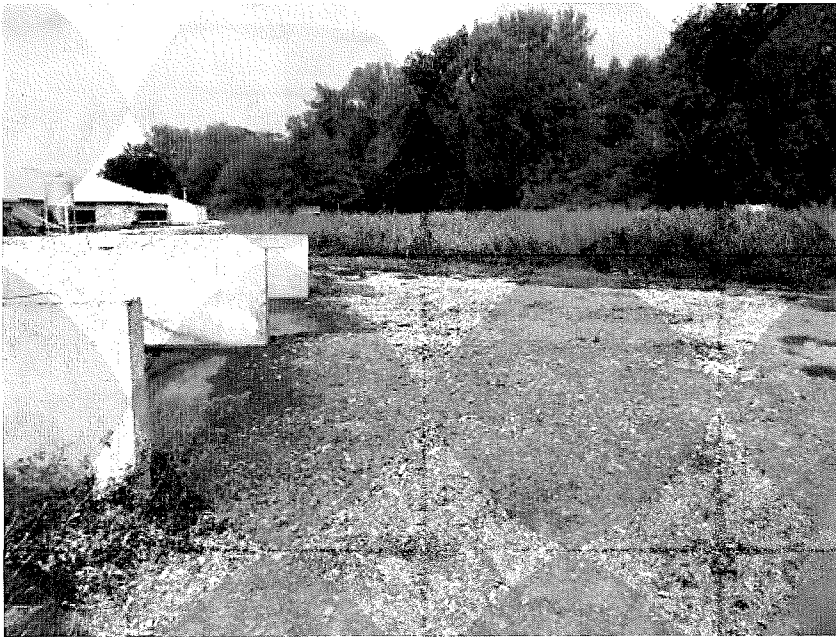
IMGP1606: East side bins of the North Compost Unit.

Location: North Compost Unit

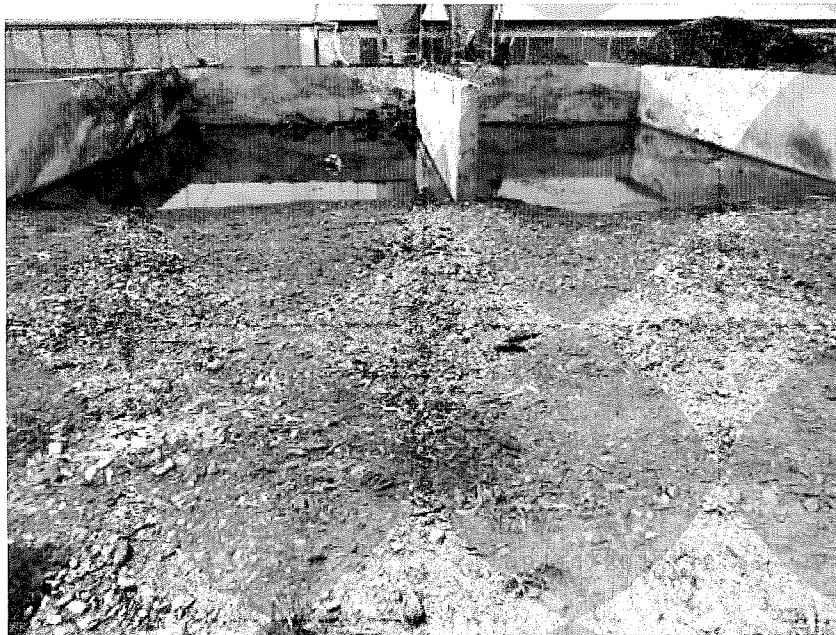
IMGP1607: Standing liquid in east bins of the North Compost Unit was process wastewater from decomposing animals and storm water. A large number of flies were breeding in the standing water.

Location: North Compost Unit

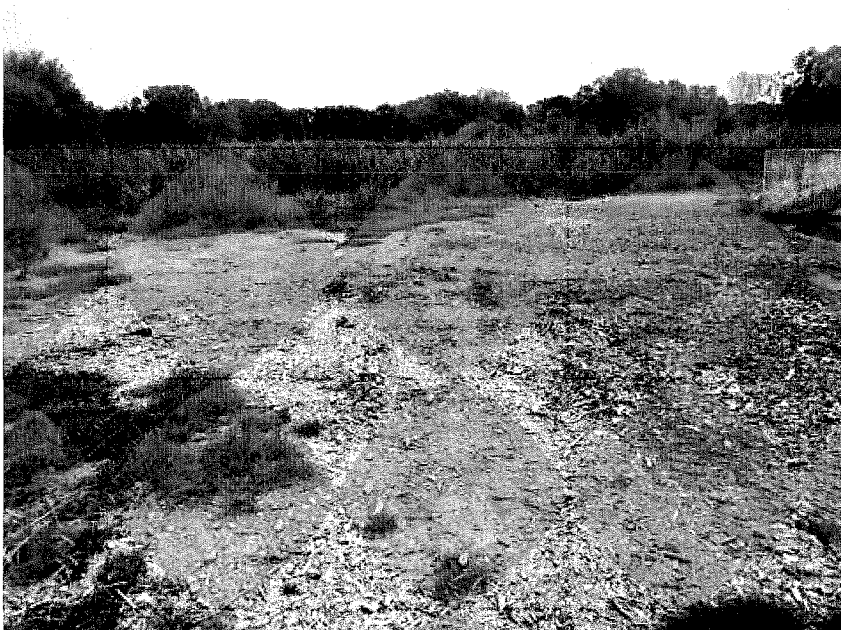
IMGP1608: Animal bones on the ground around the North Compost Unit.  
Location: North Compost Unit  
Facing: South  
Date/Time: 09/14/12 12:16 P.M.

6. The cracks in the concrete walls of the South Gestation Building should be repaired to prevent manure from leaking from the pit below the building.
7. The presence of bones from mortalities around the North Compost Unit is evidence that the mortalities are not properly covered with composting material.

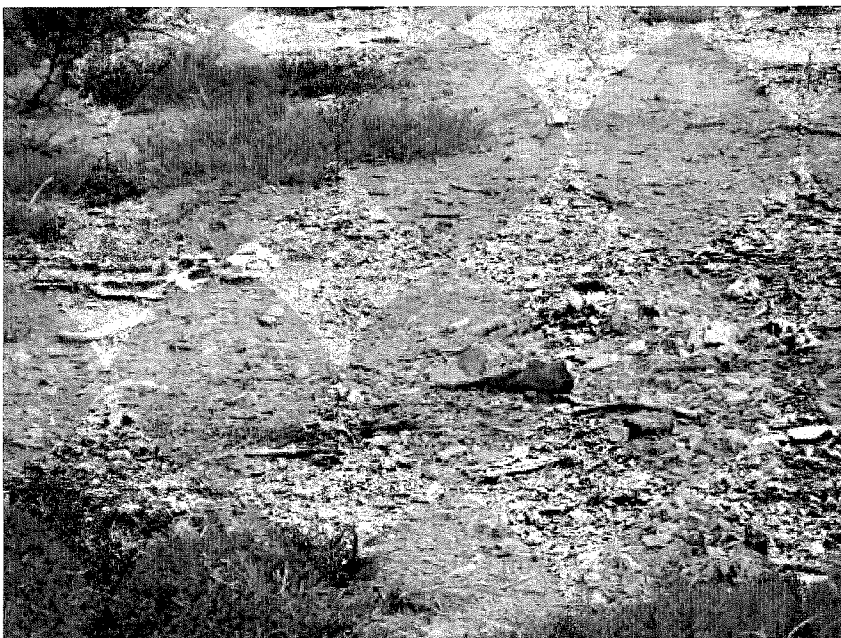
IMGP1609: Animal bones on the ground around the North Compost Unit.  
Location: North Compost Unit  
Facing: South and down  
Date/Time: 09/14/12 12:16 P.M.

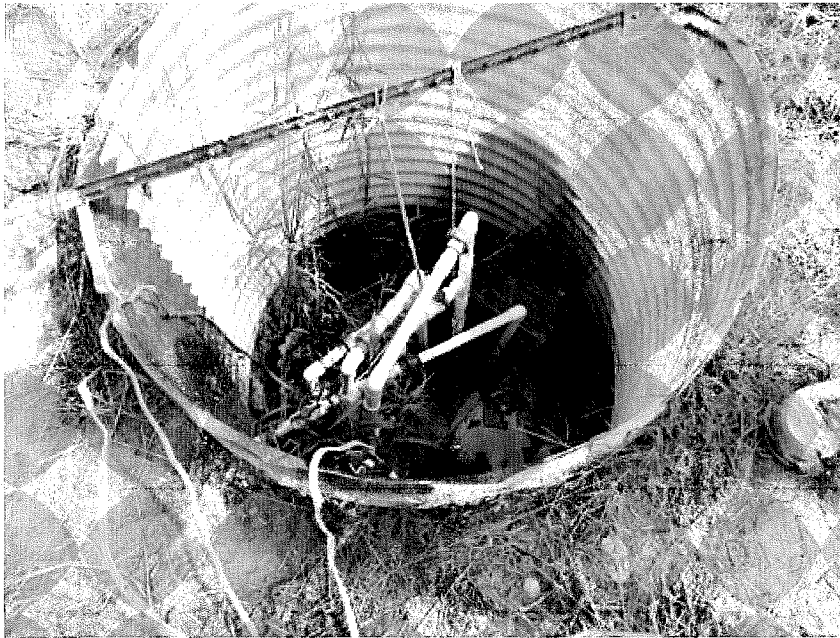
IMGP1611: An underground tank for drinking water.

Location: Northeast of Gestation Building A

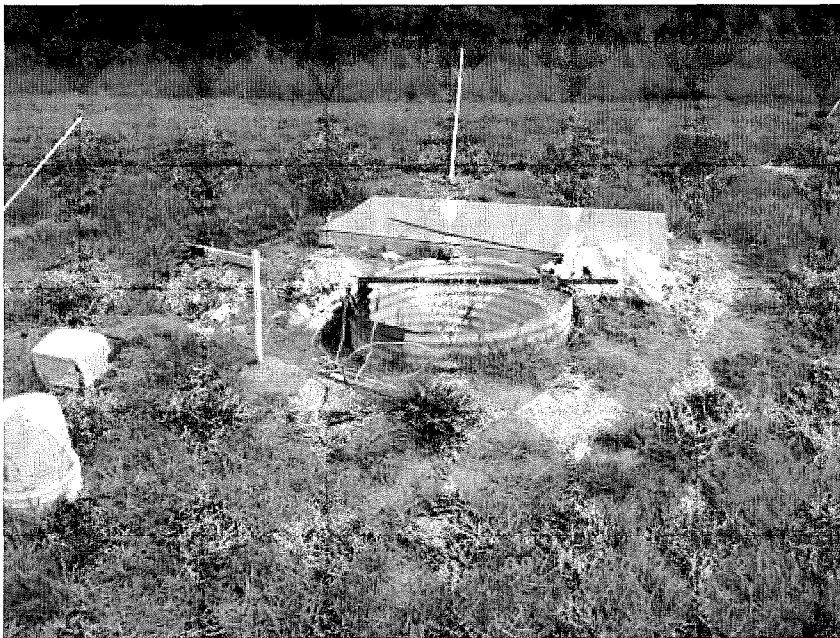
IMGP1612: An underground tank for drinking water.

Location: Northeast of Gestation Building A

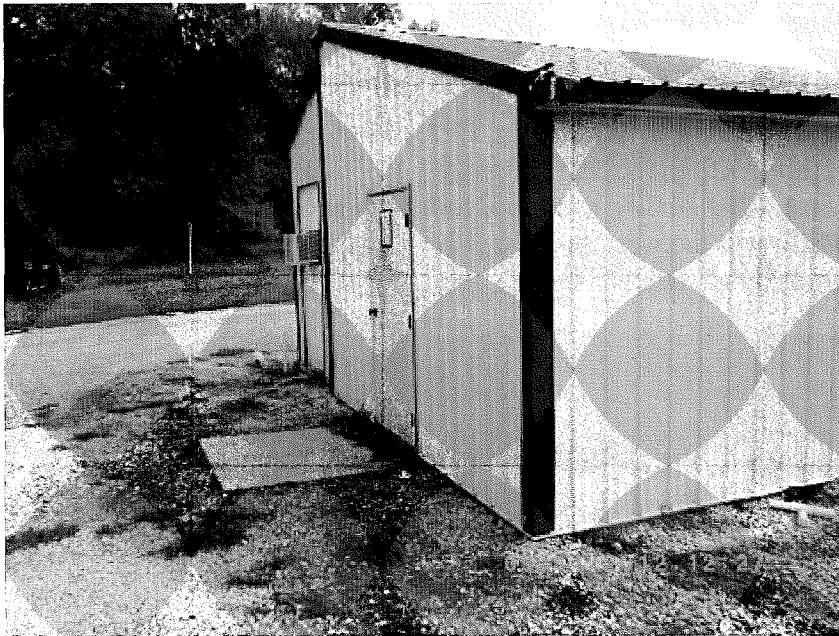
IMGP1613: Office building for the facility. A shower in the office discharges shower water to the Concrete Pit.

Location: North side of facility

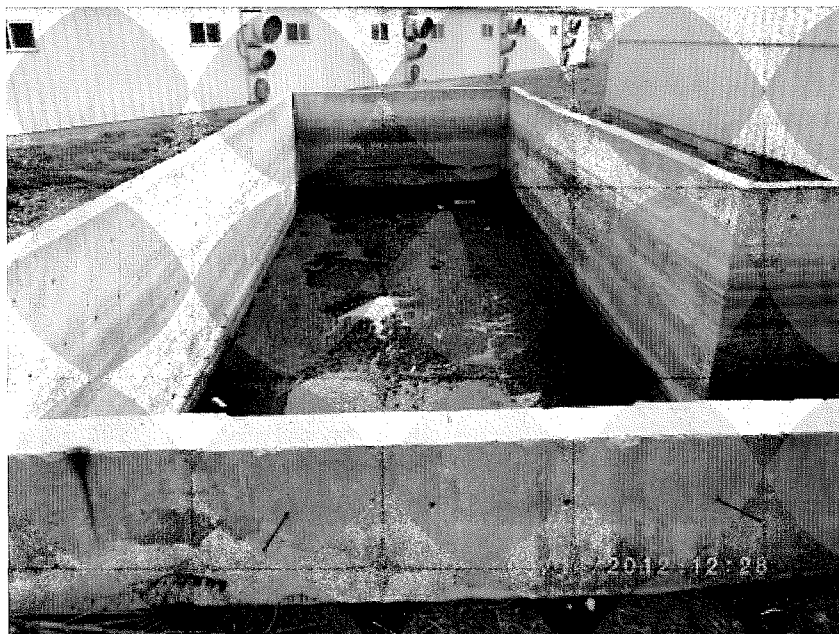
A Concrete Manure Pit on the northeast side of the Office Building stood unused. This pit still had manure and process wastewater in it. It previously was used to contain manure for the building that is now used as an office, when the building was used to

maintain animals. This building did not have a pit beneath it so this Concrete Manure Pit was built.

IMGP1614: An unused Concrete Manure Pit on the northeast side of the Office Building still has manure and process wastewater in it.

Location: Northeast of Office Building

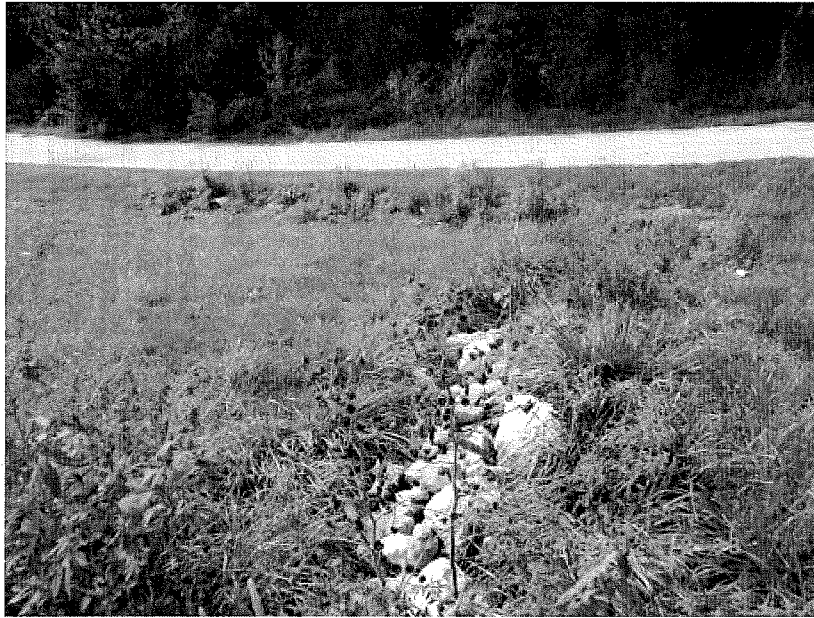
After providing a closing conference to Mr. Wittig, EPA observed the storm water channel in the yard to the north of the facility buildings. A tile drain pipe had its outlet in the yard east of Taylor Lane. The facility had place rocks in the channel below the drain. Flow from this tile would flow to the west and to a culvert under Taylor Lane. There was no flow from the tile on the day of the inspection.

IMGP1616: Storm water channel north of the facility leads to a culvert under Taylor Lane.

Location: Along Taylor Lane north of facility

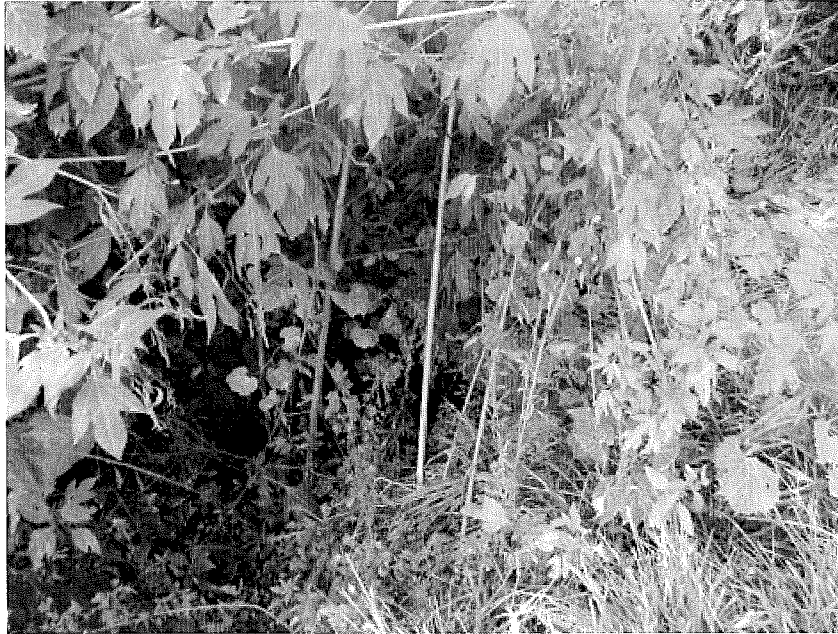
IMGP1617: Outlet for storm water pipe in yard on north side of facility.

Location: In yard north of facility
